ENGINEER'S CONSTRUCTION OBSERVATION REPORT

Project: Queen's Gap		Project Number: 2013-002
Contractor: Site Development Corporation		Contact at Site: J. Worley
Date: 04/04/2016	Time of Arrival	Weather Conditions: Workable soils.
Notice to Proceed:		Substantial Completion Date:
Previous Rain Days:		Previous Substantial Completion Date:
Rain Days Since Last Report:	Total Rain Days:	Current Substantial Completion Date:

Site inspection for Project 3 and 5 areas.

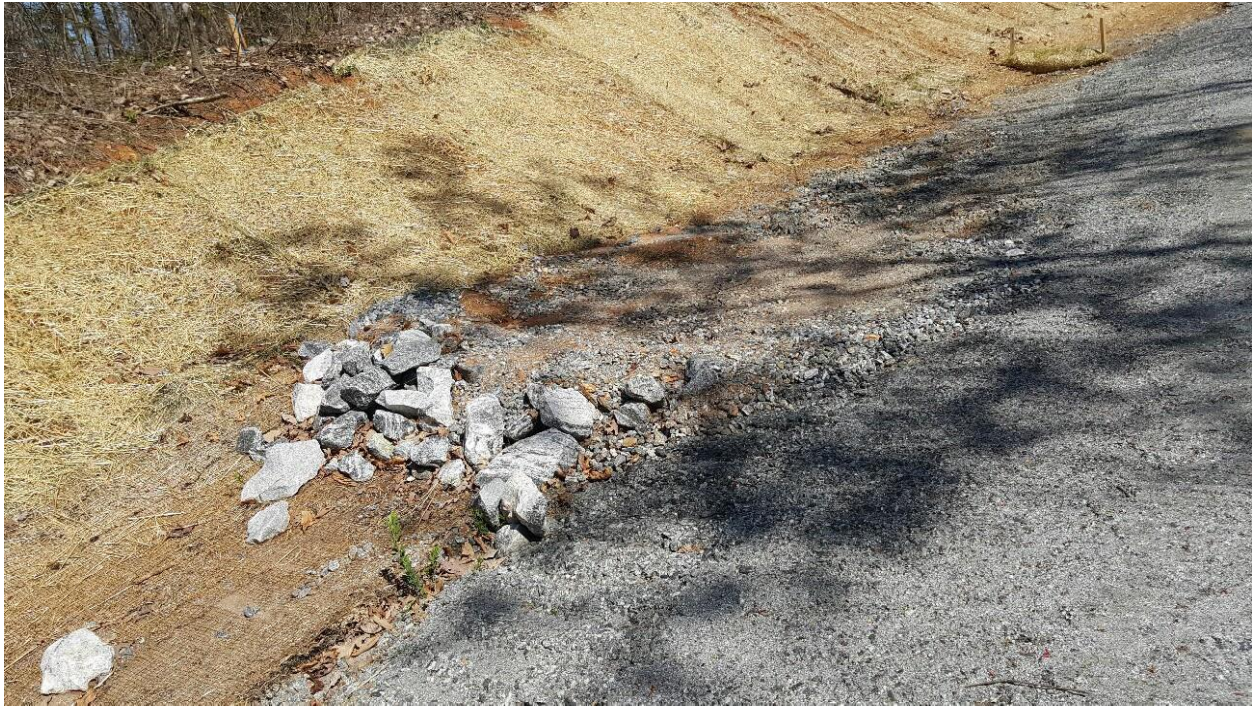
Sediment to be removed at rock ckheck dams (typical).

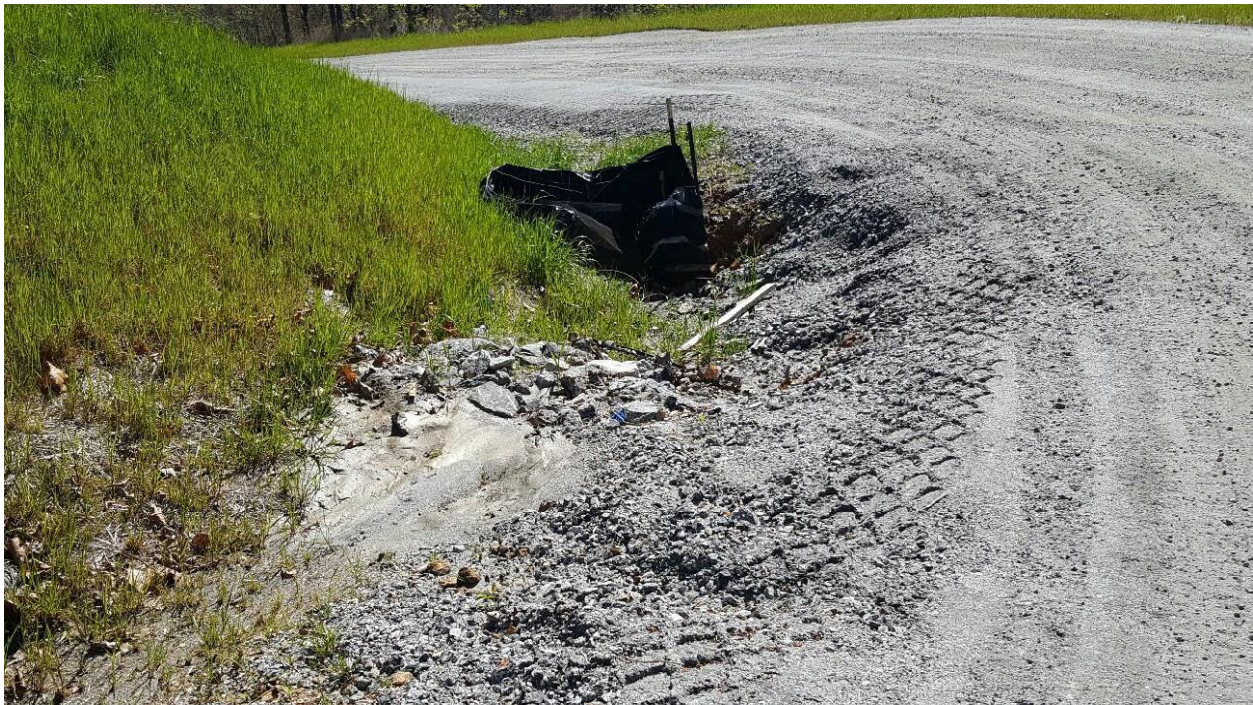
Rock check dams full – remove accumulated sediment, restore to working order. Failing Drop Inlet protection, restore to working order.

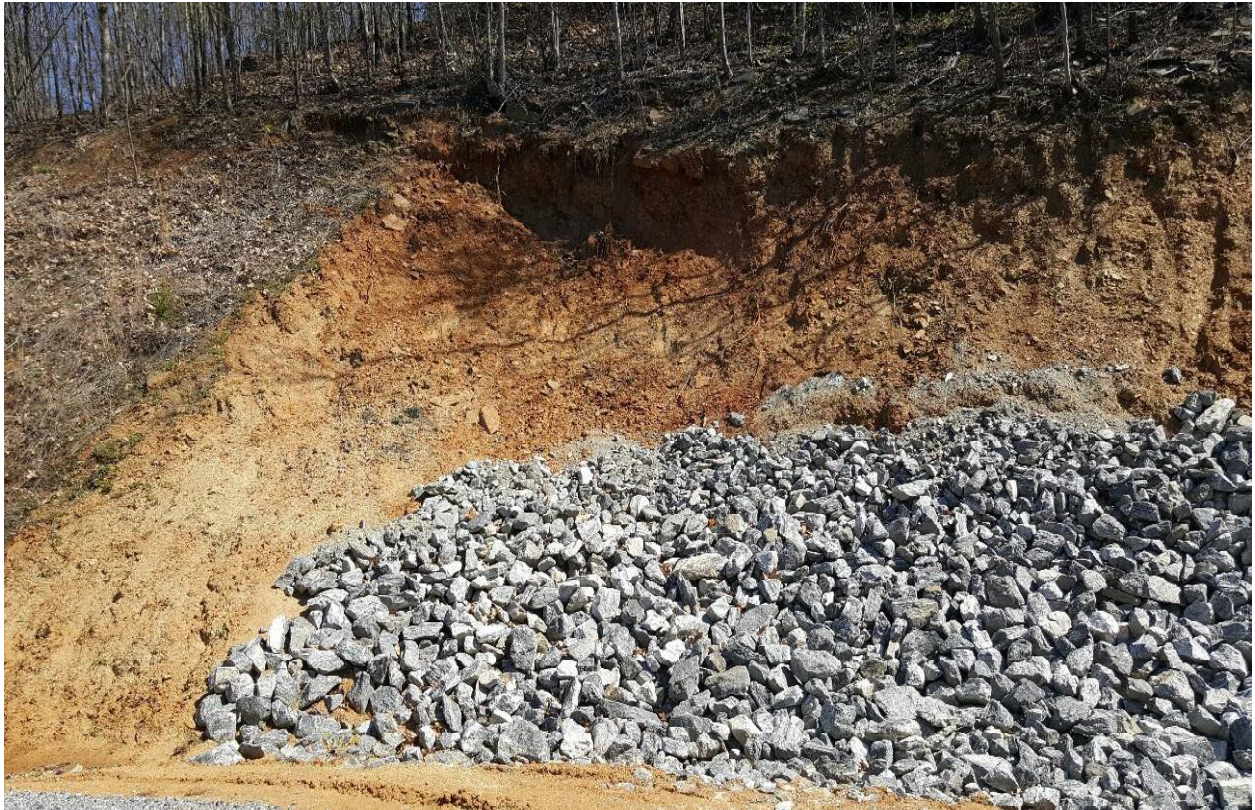
Slope repair in Project 3 area. Area above rip-rap hydro seeded.

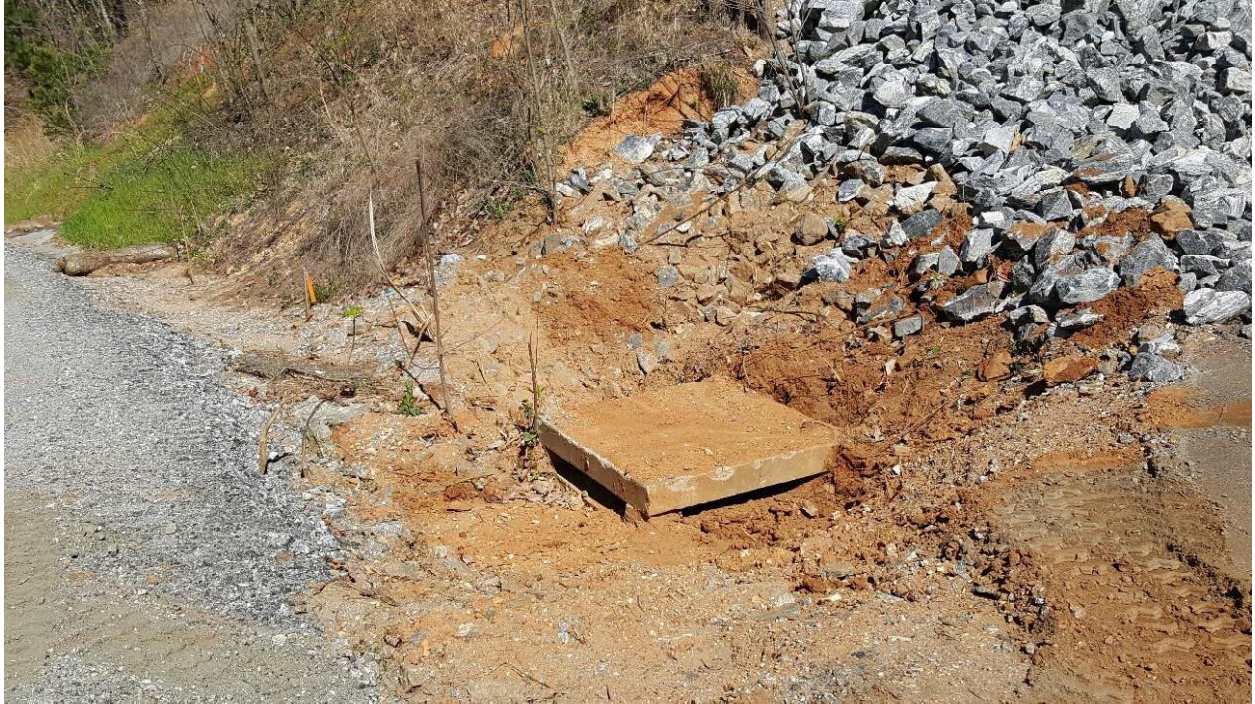
Area in Project 3 – restoration and stabilization required.

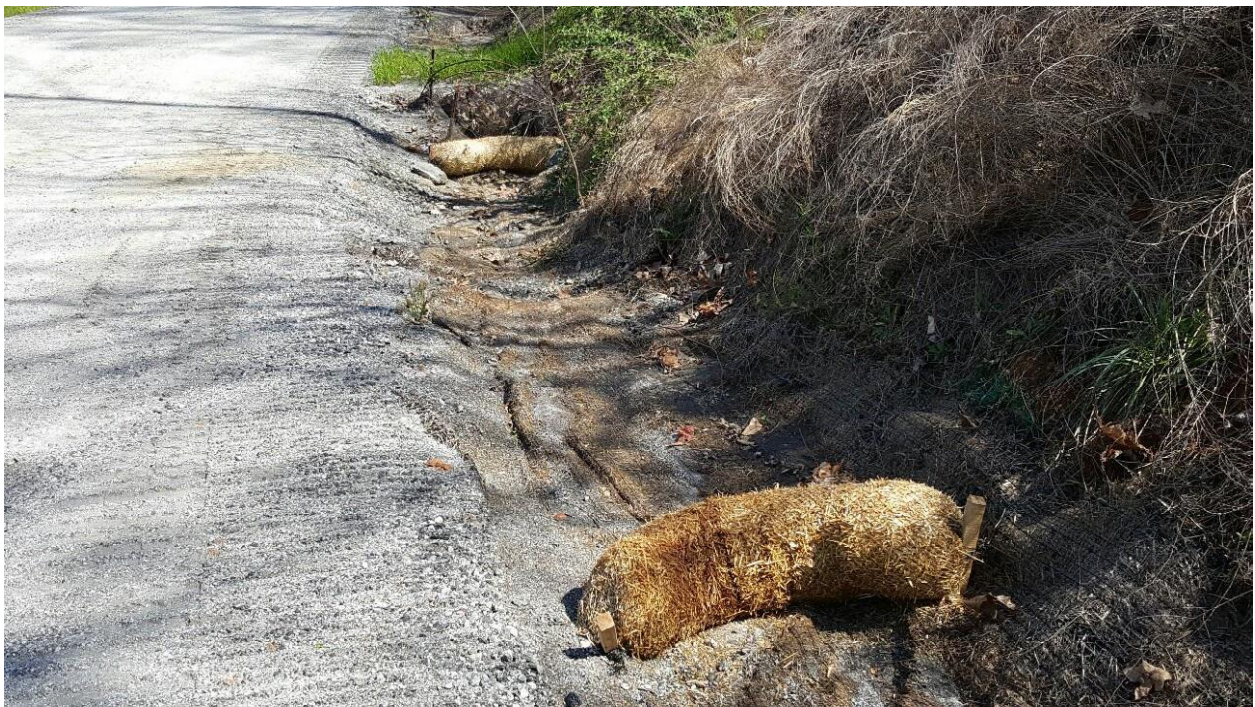
New wattle installed. Ditch line repair and restoration is required.
